Ensuring Clinical Efficacy and Patient Safety With Repaired Ultrasound Probes

Timothy A. Bigelow, PhD, G. Wayne Moore, BSc, MA, James A. Zagzebski, PhD

From the Center for Nondestructive Evaluation, Iowa State University, Ames, Iowa USA (T.A.B.); Acertara Acoustic Laboratories, Longmont, Colorado USA (G.W.M.); and Department of Medical Physics, University of Wisconsin, Madison, Wisconsin USA (J.A.Z.).

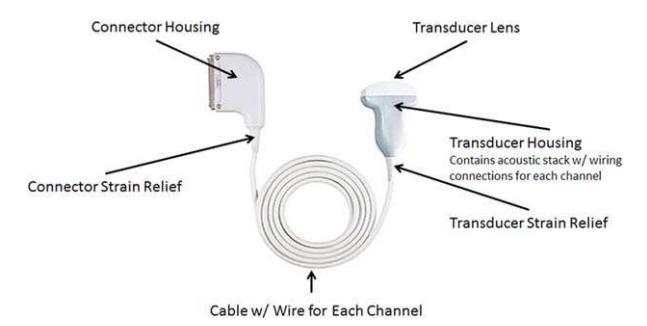
The configuration for a standard general imaging probe is shown in Figure 1, and a TEE probe is shown in Figure 2. Notable in each example is a connector that allows bidirectional transmission of electrical signals between the probe and ultrasound imaging system. The connection is needed to provide power and acoustic signal paths to the acoustic stack, consisting of the piezoelectric elements and their backing and matching layers. The connection must support precise phase control of the transferred signals. The acoustic stack is protected

and stabilized within the transducer housing (standard probe) or distal tip (TEE probe). It must provide precise positioning relative to the transducer lens. Some probes, such as those used for 3/4-dimensional fetal imaging (ie, wobblers) and TEE probes, also contain coupling fluid in the transducer housing/distal tip. In addition to providing electrical isolation from the patient, the lens on a standard probe can provide additional wave front shaping to achieve the desired ultrasound beam profile in the elevational direction, and it provides protection for the acoustic stack.

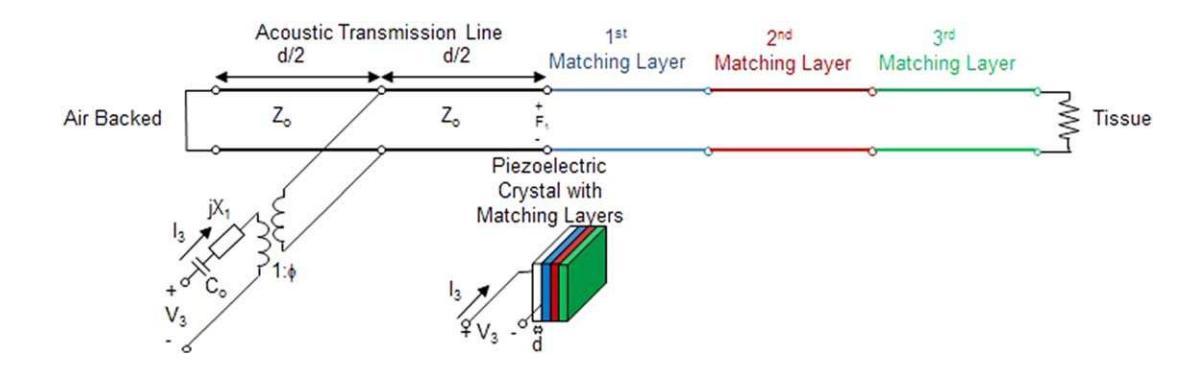
In this model, V_3 and I_3 are the respective voltage and current applied to the piezoelectric crystal, which produces the resulting acoustic forces and particle velocities at the faces of the crystal. The model parameters include the thickness of the crystal, d, the area of the

Figure 3. KLM model with 3 matching layers for our illustrative example.

crystal, *A*, and the characteristic impedance of the acoustic transmission line (ie, the radiation impedance) modeling the piezoelectric crystal, Z_o . To complete the model, it is also necessary to include a capacitor, C_o , impedance, jX_1 , and a transformer with the ratio (1: ϕ) that converts the electrical signal into the appropriate acoustical values. C_o results from the resonator consisting of a dielectric, the piezoelectric crystal, between 2 excited conducting surfaces. The values for these parameters are given by

With the use of the KLM model, both the transmitted pressure waveform into the tissue and the total power lost in the acoustic stack was calculated, as our "repaired" probes deviated from the ideal case when the probe was excited by a single-cycle pulse at the resonance frequency (3.5 MHz) for V_3 using custom code programmed in MATLAB (The MathWorks Inc, Natick, MA). In all of our simulations, the voltage amplitude of this single-cycle pulse was kept constant. This approach is a simplification of the problem, as changes in the properties of the matching layers could affect this voltage depending on the output impedance of the driving circuitry connected to the probe. However, given the potential for numerous drive configurations, this complication was not included in our illustrative example. To assist in our comparison between the optimal and repaired probes, the pulse duration and peak-peak pressure amplitude values were calculated. For our purpose, we defined the pulse duration as the time beyond which the oscillations were equal to or greater than 10% of the peak value. The pulse duration directly relates to the axial resolution of the imaging system, whereas the peakpeak pressure amplitudes would directly relate to the radiated acoustic power and the sensitivity of the

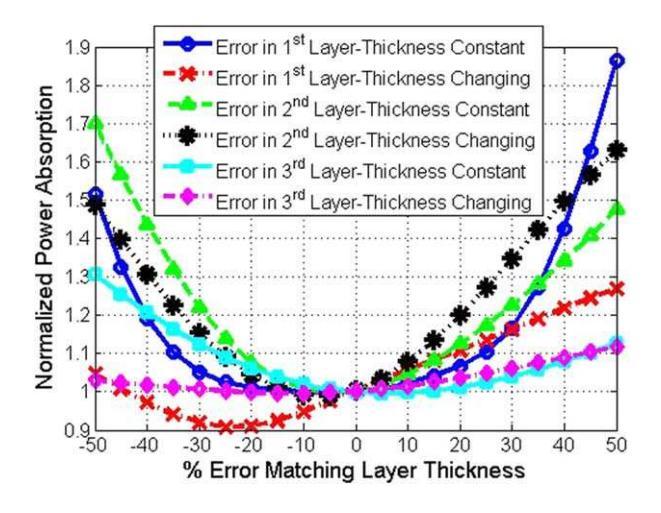
Figure 4. Normalized power absorption relative to the optimal case as a function of the error in the corresponding matching layer thickness. The results for both constant acoustic stack thickness and variable acoustic stack thickness are shown.

The results for the first set of simulations are shown in Figures 4–6. In each of these figures, the horizontal axis is the percent error in the matching layer thickness, whereas the vertical axis is the normalized values for power absorption, the pulse duration, and the output

Focusing on the second layer, errors in layer thickness on the order of 20% to 30% (only 40–60 μ m) result in a 20% to 35% increase in power absorption by the matching layer material. Therefore, if under normal conditions a standard imaging probe was warmed from room temperature (\approx 22°C) to approximately 40°C, the repaired probe could have approximately a 20% to 35% higher increase in temperature, bringing it to approximately 45°C. This temperature is beyond the safety limit and has the potential to burn the patient. In addition,

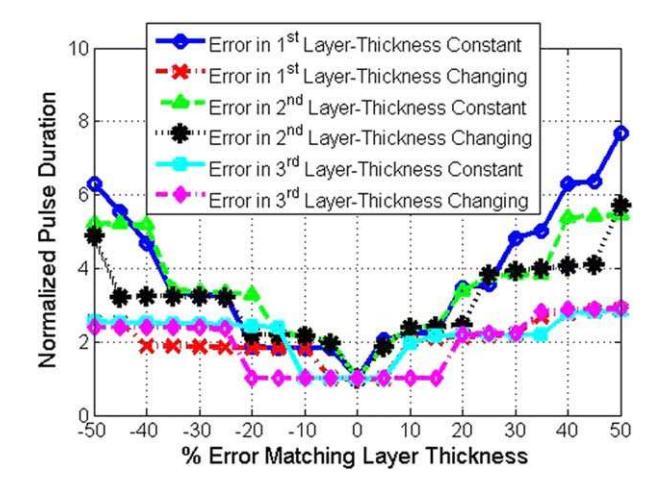
Figure 5. Normalized pulse duration relative to the optimal case as a function of the error in the corresponding matching layer thickness. The results for both constant acoustic stack thickness and variable acoustic stack thickness are shown.

peak-peak pressure amplitude, respectively. The step changes in Figure 5 are expected on the basis of our definition of pulse duration. If you recall, the pulse duration was set as the time during which the amplitude of the pulse was equal to or greater than 10% of its maximum value. Therefore, the pulse duration will jump by approximately half of the wave period as subsequent acoustic cycles increase in amplitude with the degradation of probe performance. From these figures, it is clear that errors in the thickness of the second matching layer consistently result in the largest degradation in probe performance and safety. The degradation that occurs due to errors in the first layer thickness when the overall thickness is kept constant is likely an artifact caused by the constant-thickness constraint due to the change in the second-layer thickness to compensate for the changes in the first-layer thickness. Recall that the constantthickness scenario required the second and third layers to change along with the first layer so that the overall thickness remained the same.

errors in the second-layer thickness of 20% to 30% will result in a 4-fold increase in the pulse duration. Since the pulse duration is directly related to the axial resolution in the imaging system, a 4-fold increase in the pulse duration corresponds approximately to 4 times poorer axial resolution for the imaging system. Therefore, the reduction in image quality with errors in probe repair is even more pronounced than the potential safety concerns. Last, there is some decrease in the peak-peak pressure amplitude with errors in layer thickness. Since the peakpeak pressure amplitude values only decrease under the limitations of the simulation parameters considered in this example, the field values are not anticipated to exceed the FDA level of 720 mW/cm^2 . However, the reduction in pressure amplitudes would mean a loss of sensitivity and a loss of imaging depth for the probe.

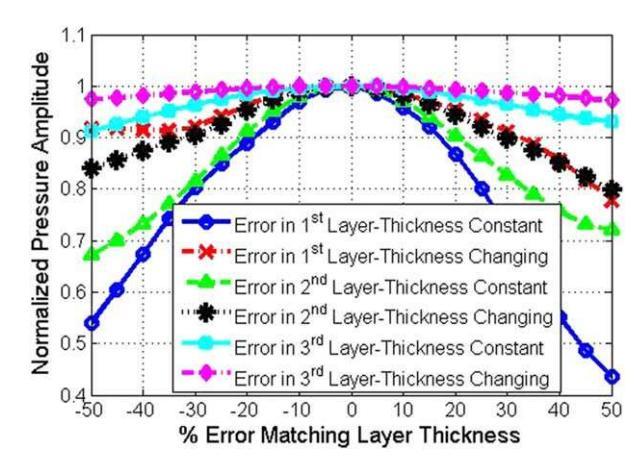
Figure 6. Normalized peak-peak pressure amplitude relative to the optimal case as a function of the error in the corresponding matching layer thickness. The results for both constant acoustic stack thickness and variable acoustic stack thickness are shown.

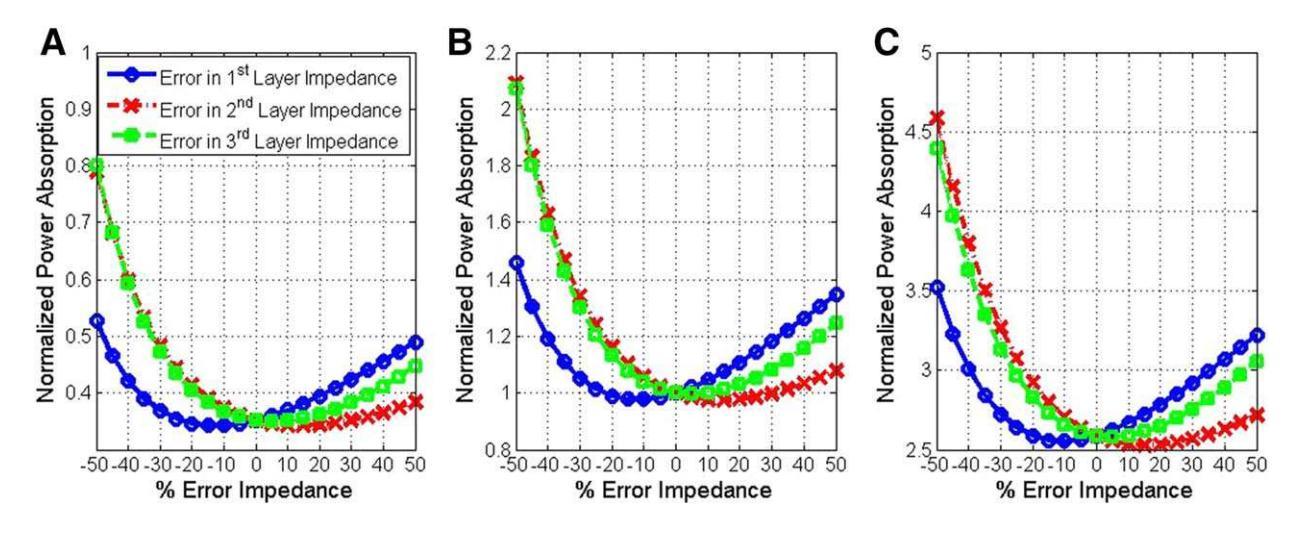
Figure 7. Normalized power absorption relative to the optimal case as a function of the error in the corresponding matching layer impedance for acoustic stack attenuations of 0.25 (A), 0.75 (B), and 2.25 (C) dB/cm-MHz.

The results for the second set of simulations are shown in Figures 7–9. For these results, the thicknesses were assumed to be the same as the optimal probe configuration, but the acoustic impedance of the layers and attenuation of the acoustic stack were varied. From Figure 7, it is clear that changes in the attenuation of the

acoustic stack dramatically affect the power absorbed within it; consequently, probe heating as the power is absorbed is 2.5 to 4 times higher for the moreattenuating material. Therefore, if a probe repair facility selects a lossy substitute layer material, probe heating can be dramatically higher than it was in the original OEM configuration. This factor is especially a concern for some epoxy composites, given their higher attenuation values. Errors in matching layer impedance are much less substantial but can still result in dramatically increased heating for large impedance mismatches. For example, a 30% drop in impedance can result in a 30% increase in power absorbed.

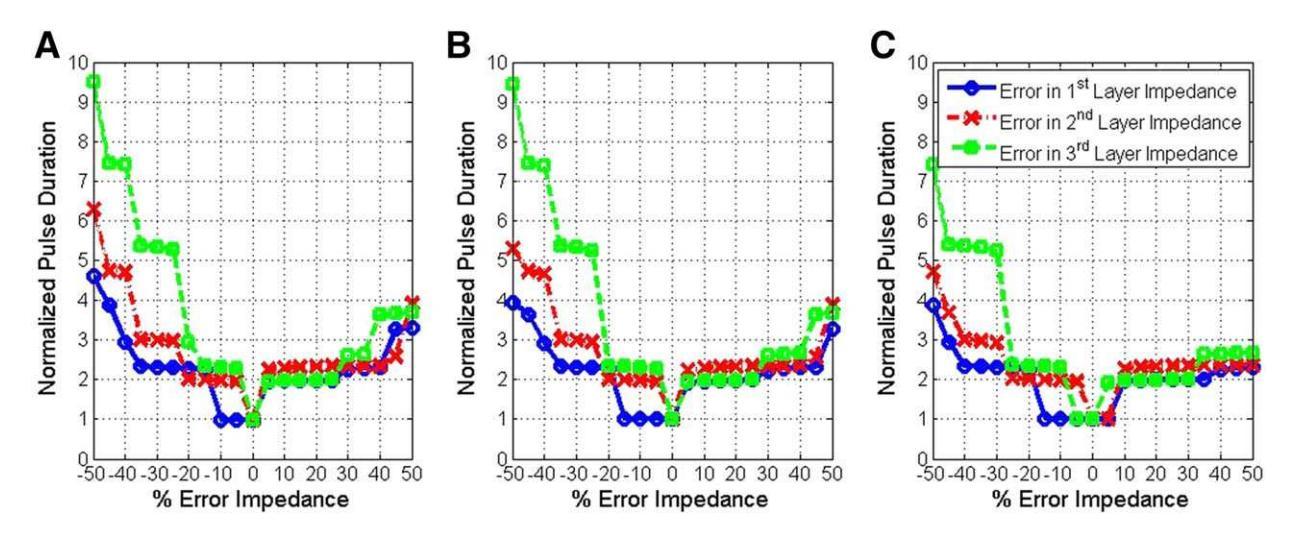
Figure 8. Normalized pulse duration relative to the optimal case as a function of the error in the corresponding matching layer impedance for acoustic stack attenuations of 0.25 (A), 0.75 (B), and 2.25 (C) dB/cm-MHz.

Figures 8 and 9 show that changes in attenuation have a relatively minimal impact on the pulse duration and the peak-peak pressure amplitude. Therefore, changes in image quality and sensitivity would not be clearly identifiable if the only deviation in material properties were the attenuation. However, substantial changes in attenuation would likely be accompanied by changes in acoustic impedance, which would result in poor spatial resolution (Figure 8) and a reduction in imaging sensitivity (Figure 9). For example, a 30% drop in impedance would give more than a factor of 5 increase in the pulse duration (Figure 8), resulting in a factor of 5 loss in image resolution as well as a 10% loss in pressure amplitude (Figure 9). The lack of dependence of the peak-peak pressure amplitude on attenuation is likely due to the relative thinness of the layers.

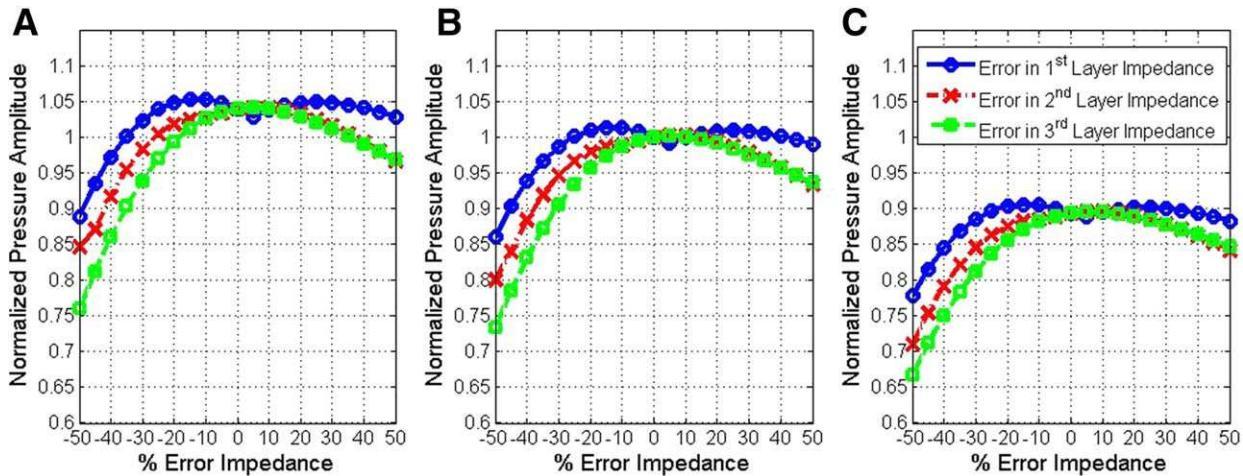
Figure 9. Normalized peak-peak pressure amplitude relative to the optimal case as a function of the error in the corresponding matching layer impedance for acoustic stack attenuations of 0.25 (A), 0.75 (B), and 2.25 (C) dB/cm-MHz.

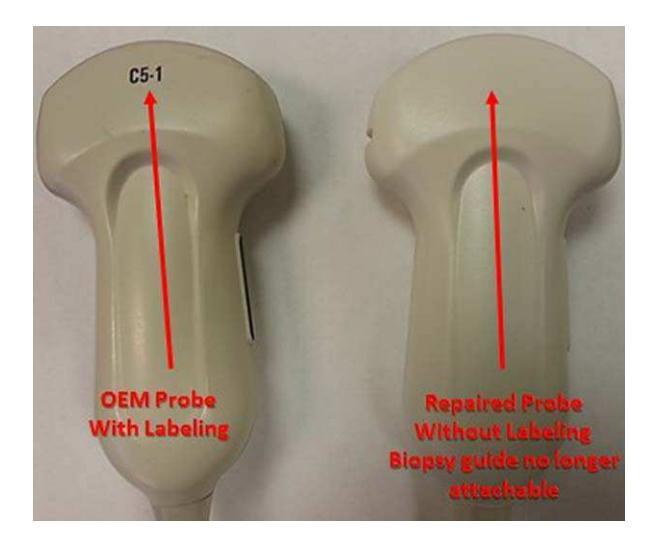
Figure 10. Original OEM probe next to a poor-quality repaired probe. The repaired probe had only 63% sensitivity relative to the original probe, was not properly labeled, and had a new case that did not allow the biopsy guide to be used.

Now that our simulations have illustrated how relatively small changes in probe construction can have a dramatic impact on ultrasound image quality and probe heating, consider some examples of actual poor-quality probe repairs. To begin, consider a third-party repaired probe in which the OEM acoustic stack was replaced with an array made by a third-party manufacturer. Also, a new transducer housing was used that had no label and, because of improper fit and design, no longer allowed the original biopsy guide to be used (Figure 10). This change could potentially create a substantial hazard to the patient, as a misregistered biopsy guide could result in sampling of the wrong tissue for biopsy, which could result in a wrong diagnosis as well as damage to sensitive tissue structures.

If we compare this reduction in sensitivity with our prior simulations, as well as consider the fact that the

probe did not fit in the original case, it is very likely that the repaired probe had errors in layer thicknesses of 50% or greater. Therefore, it is likely that in addition to poor sensitivity, this probe would have poor imaging

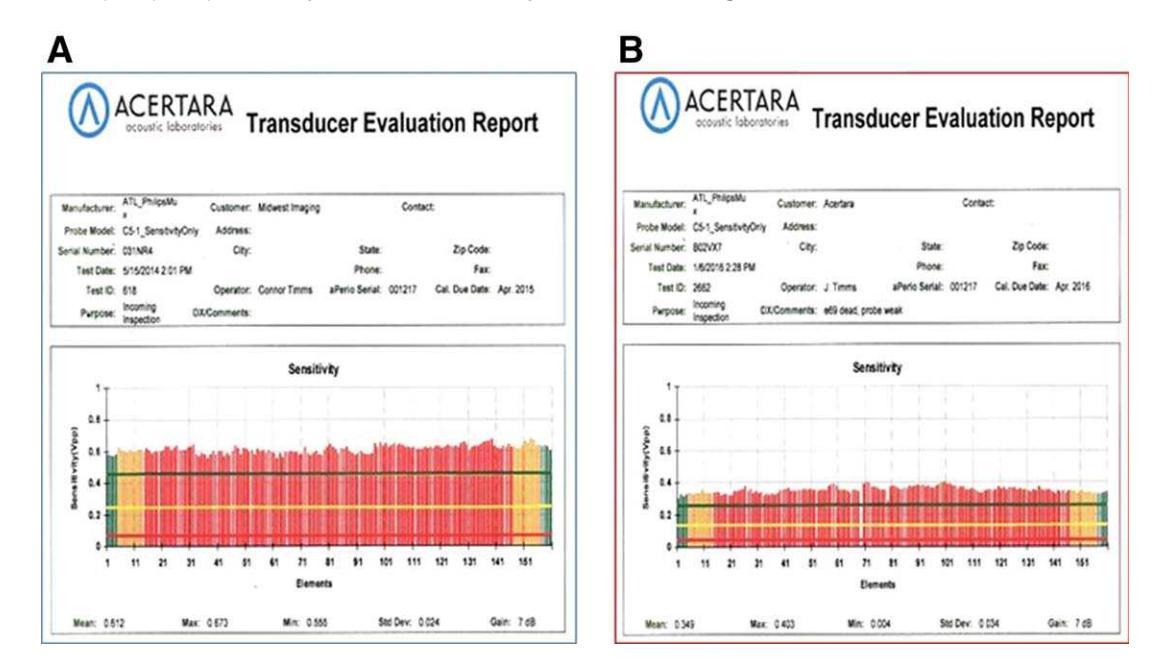
Figure 11. Sensitivity comparison of an original OEM probe (A) and a poorly repaired probe (B). Sensitivity is defined as the echo signal amplitude (volts peak-peak) produced by each element in the array for a smooth reflecting interface.

In addition to noting the new housing, the sensitivity of the non-OEM array was assessed with an electronic transducer tester (FirstCall; Acertara Acoustic Laboratories, Longmont, CO), which measured the echo amplitude from a reflecting surface for each element. The results shown in Figure 11 indicate that the sensitivity response was only 63% of that of the OEM array. The sonographers reported that this probe produced non-diagnostic-quality images, and they ceased using it.

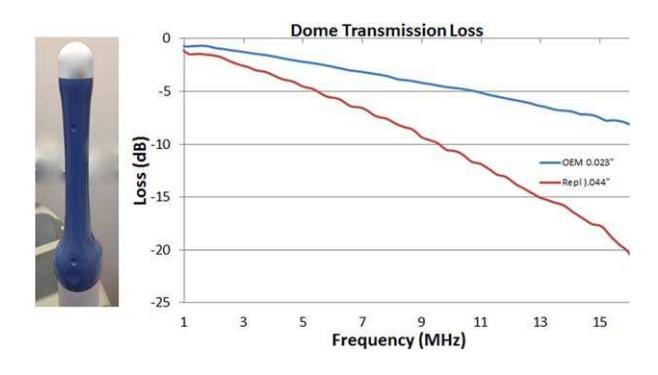
Figure 12. Dome transmission loss comparison between an original OEM probe dome (blue line) and a non-OEM dome used in a repair (red line).

Another poorly repaired probe example is shown in Figure 12 for an endocavitary transducer. The white dome (shown on the left) was replaced with a non-OEM part, and the new configuration had dramatically different signal attenuation losses from the original, ranging from 1 dB at 1 MHz to 20 dB at 15 MHz. This non-OEM replacement dome was tested for 1-way transmission loss using time delay spectrometry on an ARTIS time delay spectrometry system (Acertara Acoustic Laboratories)¹⁸ and compared to the transmission loss of an OEM dome. In clinical use, these losses are 2 way, transmit and receive, and substantially affect the clinical utility of the probe, with loss of the depth of penetration. Changes in probe material attenuation (ie, insertion loss) can also result in substantial increases in probe heating, as demonstrated by our simulations.

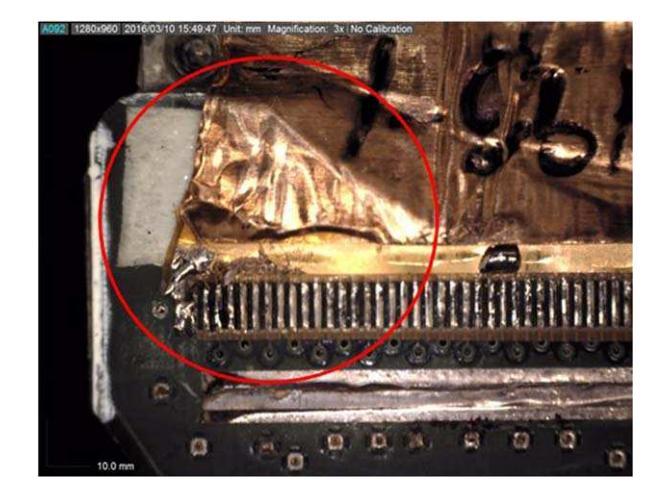
Figure 13. Poor-quality termination repair that resulted in signal dropout and increased speckle noise.

In addition to the third-party repair company's obvious lack of a quality control system, as demonstrated by a nonvalidated, non-OEM acoustic stack and the presence of probe materials that affect acoustic transmission, poor-quality repairs can also be evidenced by the lack of high-quality workmanship. For example, Figure 13 shows an example of a third-party flex circuit retermination repair at the acoustic stack, where thick solder

joints and electrical tape are found. When the clinical user received this repaired probe back, signal dropout and speckle noise were immediately noticed in the Bmode image and on color flow Doppler imaging compared to results from an identical OEM transducer. The probe was sent to an acoustics laboratory for forensic evaluation, and tests revealed the very poor retermination attempt.

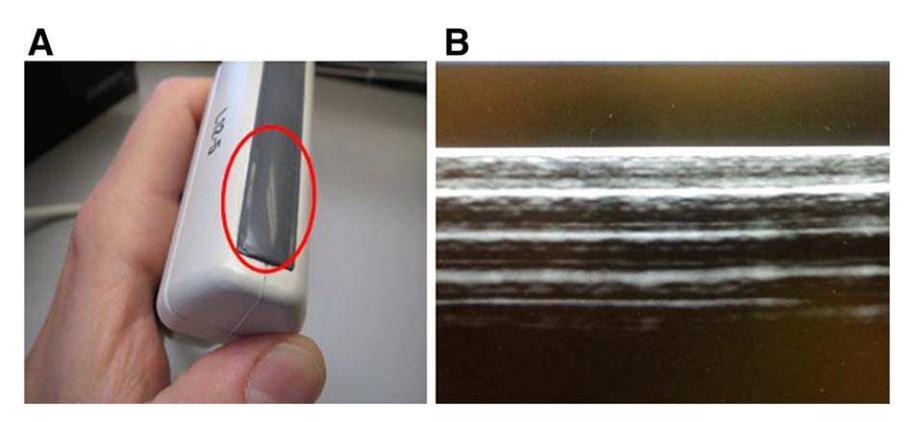
Figure 14. Improper layering of the lens material (A) resulting a tilt in the image, multiple reverberations (B), and unacceptable image quality.

Figure 14 shows another example of a repaired probe episode, in which material used to form a replacement lens was not evenly layered across the face of the transducer (one end of the lens was more than twice as thick as the opposite side). This repair resulted in a tilt in the image, multiple reverberations (Figure 14b), and unacceptable image quality. Figure 15 shows another example of a 2-dimensional array transducer (X5-1; Philips Healthcare, Bothell, WA), which was returned to Philips because of poor performance. The lens material had been replaced, as had the strain release between the cable and probe, which had cracked. A piece of the handle had also cracked, probably when the nose of the probe was removed during the repair. The nose was also poorly glued back on with a large gap.

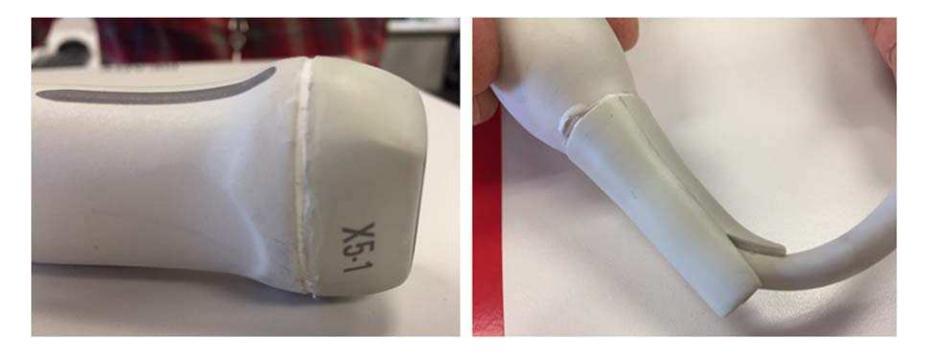
Figure 15. Poor-quality nose removal/reattachment with poor quality strain release.

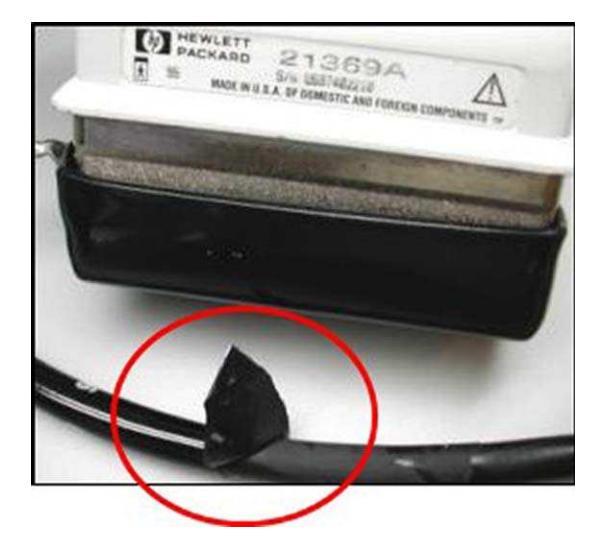
Figure 16. Use of nonbiocompatible materials on a TEE probe that came apart while in use.

Finally, poor-quality repairs are not limited to degradation of imaging performance. For example, Figure 16 shows a TEE probe repaired by using heat shrink material to cover the insertion tube. This material came apart while in use, and fragments were found in the patient's mouth on probe extraction, resulting in a substantial choking hazard to the patient.

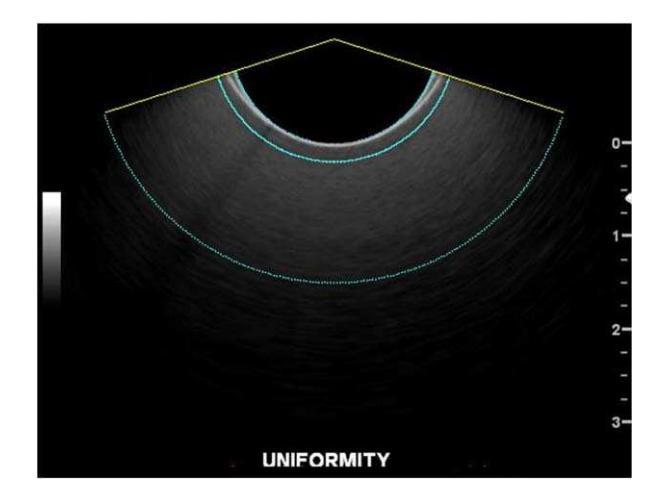
Figure 18. Median image from a cine loop obtained with a linear array transducer scanning a tissue mimicking phantom, showing element dropout (median image created with UltralQ; Cablon Medical, Leusden, the Netherlands).

A simple way to test for dead elements is to scan a uniform region in a tissue-mimicking phantom coupled very uniformly to the ultrasound transducer. For linear array probes, this process is done very easily by using a conventional tissue-mimicking phantom, since most phantoms have flat scanning windows, enabling contact with the entire surface of the transducer. One scans the uniform phantom while looking for "shadows" emanating from the transducer surface (Figure 18). Even minor faults due to one or more dead elements usually can be spotted by creating images in which the speckle signals are smoothed out. An effective way to do this assessment is to record a cine clip while the probe is translated over the phantom (note: the user should turn off image compounding during this test). Visual inspection, or creating either an average image from the clip or, as in the case shown below, a median image helps document the element dropout.¹⁹

Special scanning windows or even scan wells are available on some tissue phantoms to enable the entire scanning surface to be in contact with tissue-mimicking material. Figure 19 shows a median image recorded from a 150-image cine loop for an endocavitary transducer. The phantom was a simple Uniformity TE phantom (Gammex RMI, Middleton, WI) from a manufacturer. Although difficult to spot on clinical

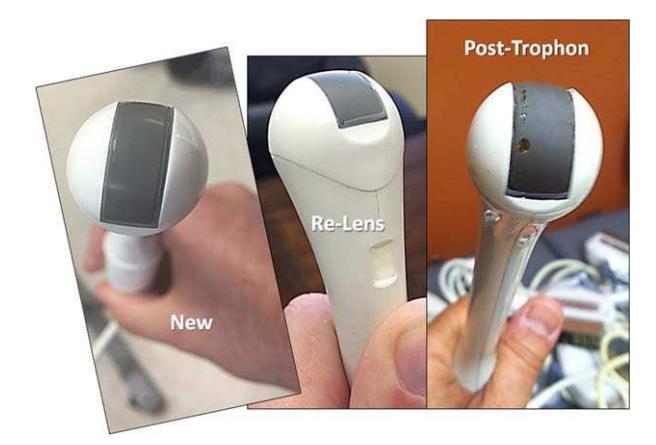
Figure 17. Use of different materials on a transvaginal probe eliminated the approved method of disinfection.

Figure 17 shows another example of improper material selection (non-OEM) for the replacement lens of an E8C-RS transvaginal probe (GE Healthcare,

Milwaukee, WI). Because of the validation testing performed by GE, the OEM probe can be safely cleaned with the Trophon disinfection system (Trophon EPR; Nanosonics Ltd, Lane Cove, New South Wales, Australia). However, when the repaired probe with different non-OEM lens material was used, the probe was damaged by the Trophon system. Therefore, a previously approved method of disinfection was no longer valid. Without proper cleansing, the risk of infection from cross contamination is substantial. It is also important to note that both the adhesion epoxies and lens materials require proper curing to be biocompatible. The FDA requires testing on any of these materials that are process dependent to confirm biocompatibility.

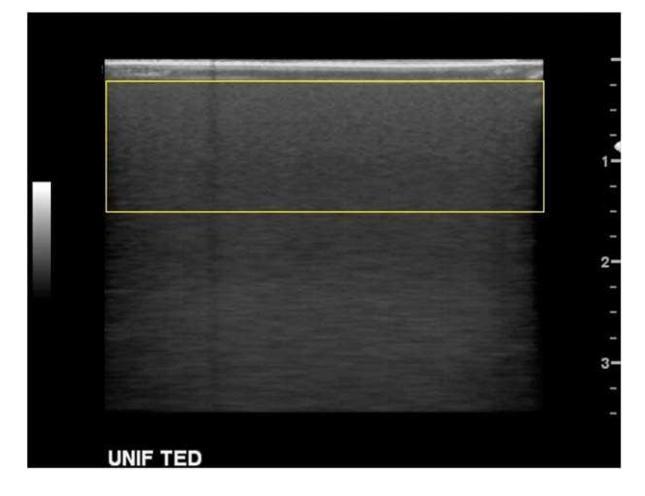
Figure 19. Median image from a cine loop obtained with a curvilinear probe scanning a tissue mimicking phantom, showing element dropout (median image created with UltralQ).

images, both phantom images vividly show nonuniformities, presumably caused by element dropout.
