On the Proper Care of a Transesophageal (TEE) Probe

G. Wayne Moore, B.Sc., MA, FASE
Acertara Acoustic Laboratories

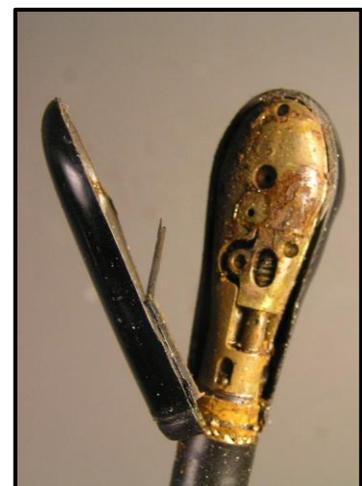
Many of the failures outlined above associated with fluid ingress can be repaired, but if the corrosion damage is not caught early enough in the process the severity of the damage sometimes cannot be completely reversed and will eventually result in the necessity of replacing the TEE probe. Therefore it is essential that after every TEE procedure the probe insertion tube be closely inspected for any compromise to the integrity of the insulation. If a hole, suspected hole, or cut is seen in the insertion tube area, the probe should not be disinfected until electrical leakage and FirstCall⁶ or Aureon⁷ testing is performed by the Biomedical Engineer. The electrical leakage testing can be done with a device such as the iTest⁸ ultrasound leakage tester or the testing device provided with the TEE probe by the OEM. The FirstCall and Aureon devices are used by the Biomedical Engineer to determine any array, or element involvement. Electrical leakage testing should also be performed prior to or at the very beginning of the disinfection cycle, to avoid possible fluid infiltration into the TEE probe. A probe that fails electrical leakage must be taken out of use immediately, and not submerged into cleaning solvent.

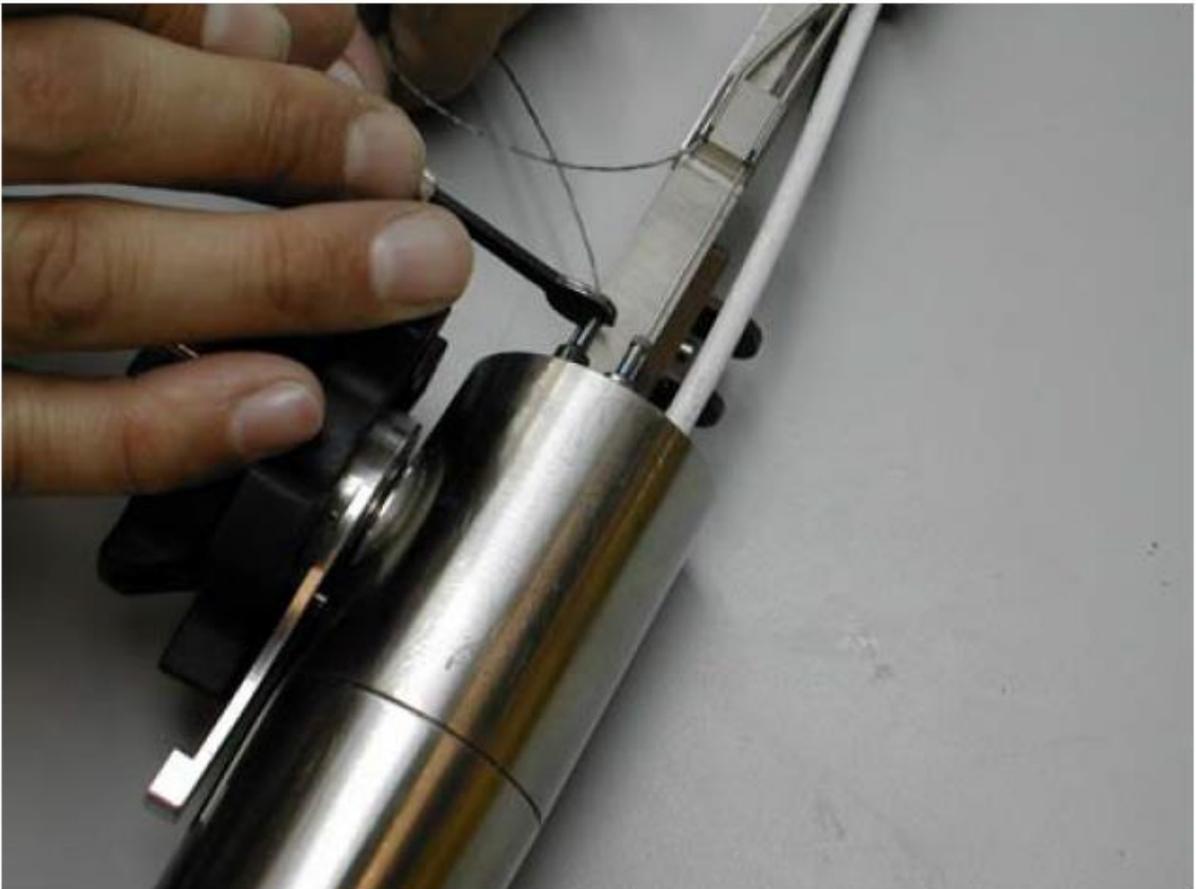
Control Housing Articulation Wires

The articulation mechanism is comprised of control knobs on the control housing of the TEE probe, which connect to very thin cables that are routed through the insertion tube to the scanhead (tip). The articulation knobs are used to move the tip of the TEE probe (along with the transducer array) into various positions and angles needed in order to obtain and maximize the desired scan image or Doppler. Over time and with frequency of use, this articulation mechanism will wear (e.g., loosen, or become "sloppy" and unresponsive), be damaged by fluid infiltration and the resultant corrosion, or be damaged by improper handling and use of the TEE probe. As stated earlier in this paper, a failure of the articulation mechanism while the probe is inserted into the patient's esophagus presents a potential safety hazard. For this reason, daily testing of the articulation mechanism is important to detect any changes in the mechanical performance of the mechanism so that repairs can be made early in the failure process. Personnel that use or clean TEE probes regularly should be trained to do this articulation testing and know what to look for in terms of changes in performance or function. In-house biomedical engineering personnel, OEM personnel, or an independent ultrasound field service engineer should also check the articulation performance during regularly scheduled preventive maintenance service calls. Depending upon frequency of use, it is recommended that this mechanical inspection be done once per day and any changes noted in an equipment log.

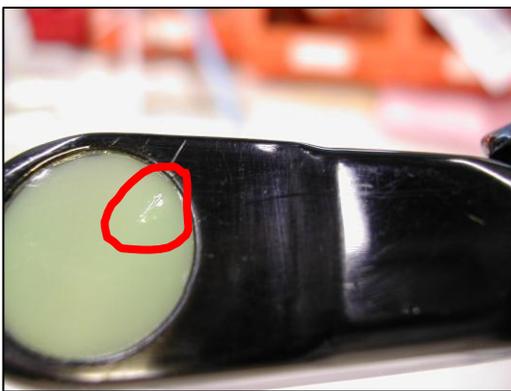
**Scratching on the
Acoustic Lens**

Defects like those shown above may be sources of biological loading if not cleaned properly; extra care should be given in cleaning any TEE probe that has excessive wear, or indentations.

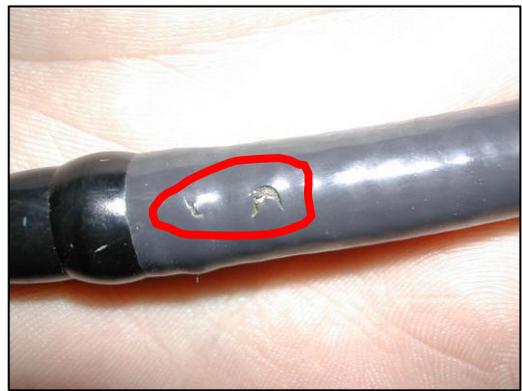
**Tooth Drag Marks on
Insertion Tube Sleeve**

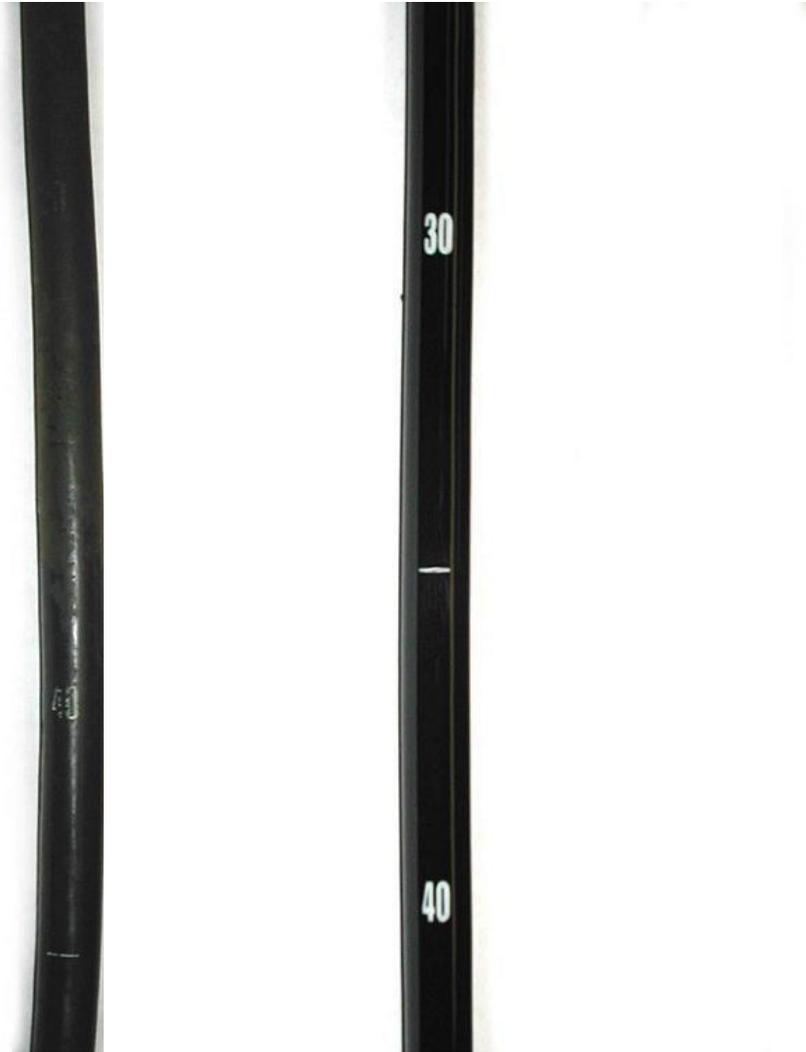
Before Re-label

After Re-label

One of the more common needs for repair on TEE probes is to re-coat and re-label the depth markers (shown above). These marks fade as a function of use and through the disinfecting process, especially if the disinfecting process is a manual one where over-soaking can be a potential problem. After the Acertara re-coating and re-labeling process, the depth markers and the outer protective coating of the TEE insertion tube are fully restored to their original new condition. It should be noted that OEMs generally do not cover discoloration or fading under warranty.¹¹

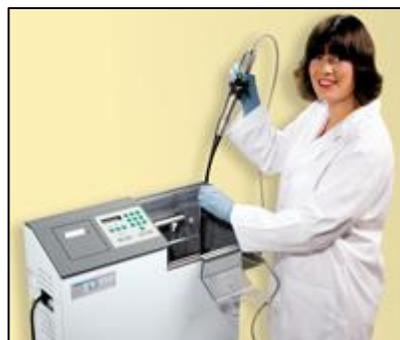
Automated TEE Disinfection Device

The use of a specially designed, FDA 510(k) cleared, automated TEE disinfecting device such as the CS Medical (see Page 11) model TD-100¹⁰ is highly recommended for safely, consistently, and effectively disinfecting TEE probes. This automated device mitigates many handling and cleaning issues that are primary causes for TEE probe after-use failures associated with handling and over-soaking.
